LITTLE NACHES RIVER PASSAGE PROJECT

Annual Report FY90 and FY89

Annual Report FY89

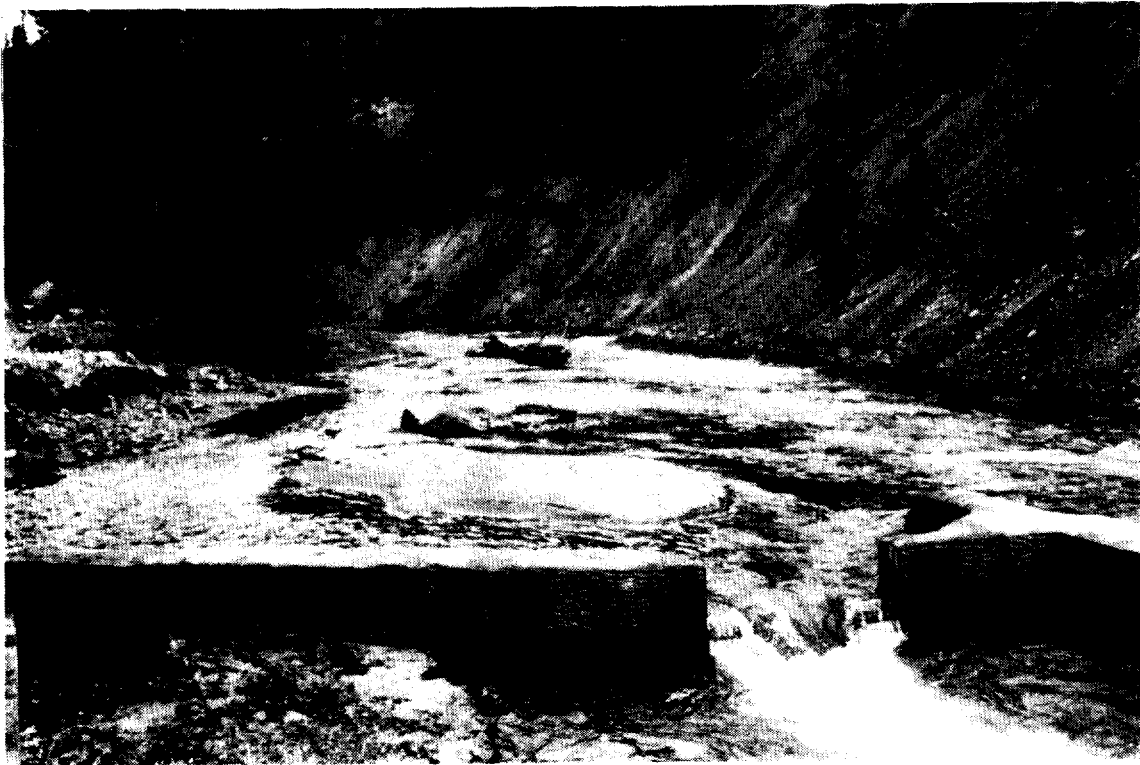
SALMON FALLS FISHLADDER
UPSTREAM END JULY 1988
GRAVEL BAR NEAR EXIT

A gravel bar has formed just upstream of the fishway since it was completed in November 1987. The bar was not creating any passage problems until the flood event on November 25, 1990. After that event the bar increased in size and diverted the entire river flow away from the ladder and over the Falls. It previously had been suggested that the fishway exit (upstream end) be blocked during high flows in an effort to direct more of the bedload over the falls and allow less into the fishway. The fishway exit was boarded this winter to test this hypothesis, and may have contributed to the increased bedload deposition on the bar.

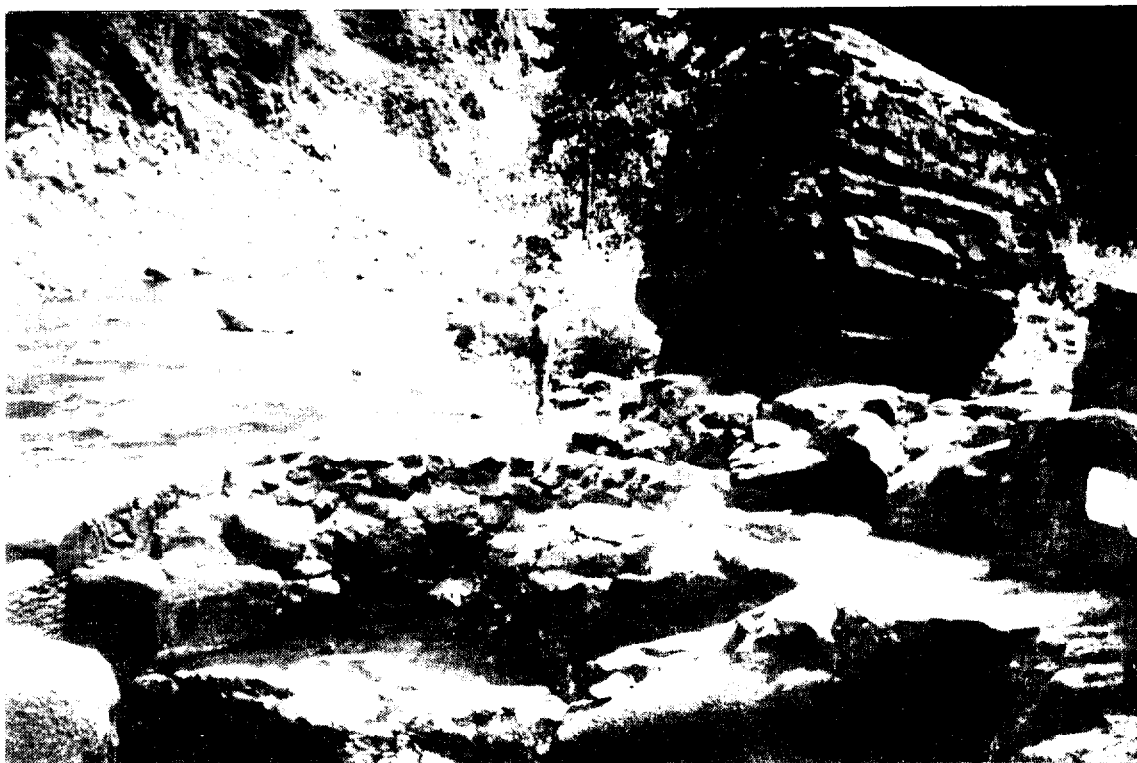
SALMON FALLS FISHLADDER
DOWNSTREAM END NEAR BALANCING ROCK
AUGUST 1, 1989

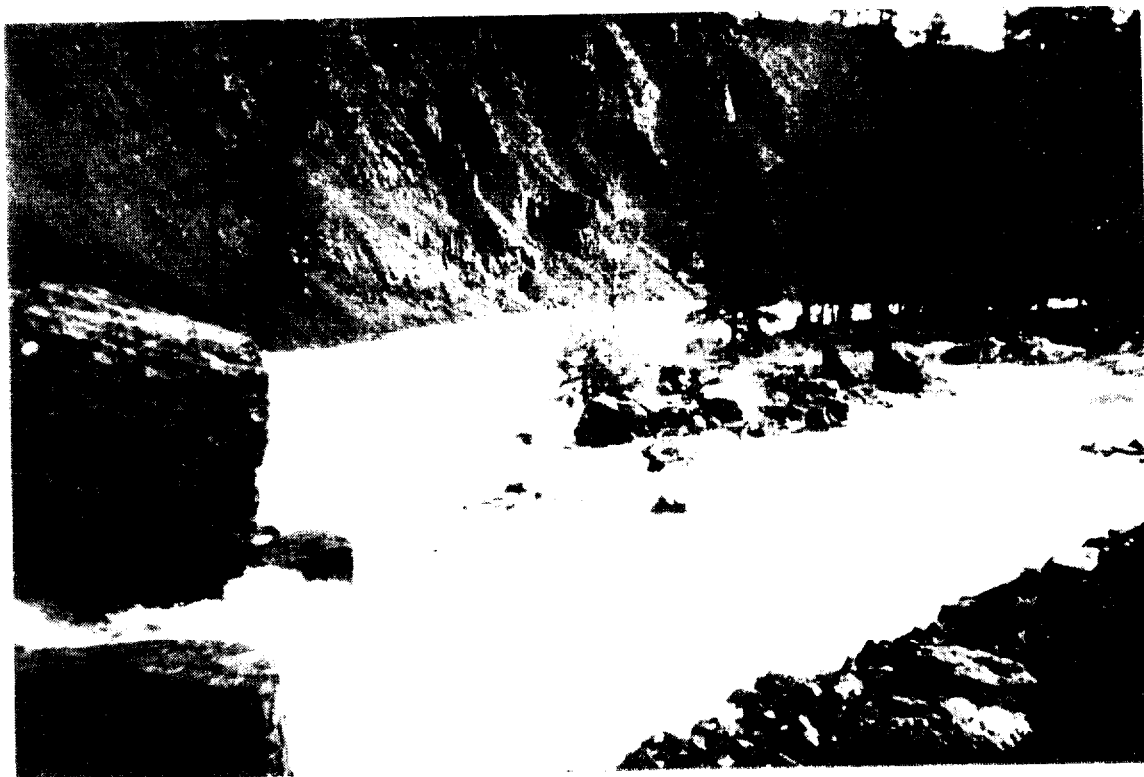
SALMON FALLS FISHLADDER
DOWNSTREAM END NEAR BALANCING ROCK
FLOOD EVENT NOVEMBER 25, 1990

A preliminary survey of the fishway after the flood event on November 25, 1990 indicated that the structure is intact. Increased erosion on the streambank at the top of the Falls appears not to have adversely affected the anchoring of the concrete grade control structure. The concrete structure itself may have sustained some damage (pieces chipped off). Until a more thorough evaluation can be made, the only other observed impact is a substantial collection of bedload in the pools. Flood relief funds have been applied for to survey and repair any damage to the fishway.

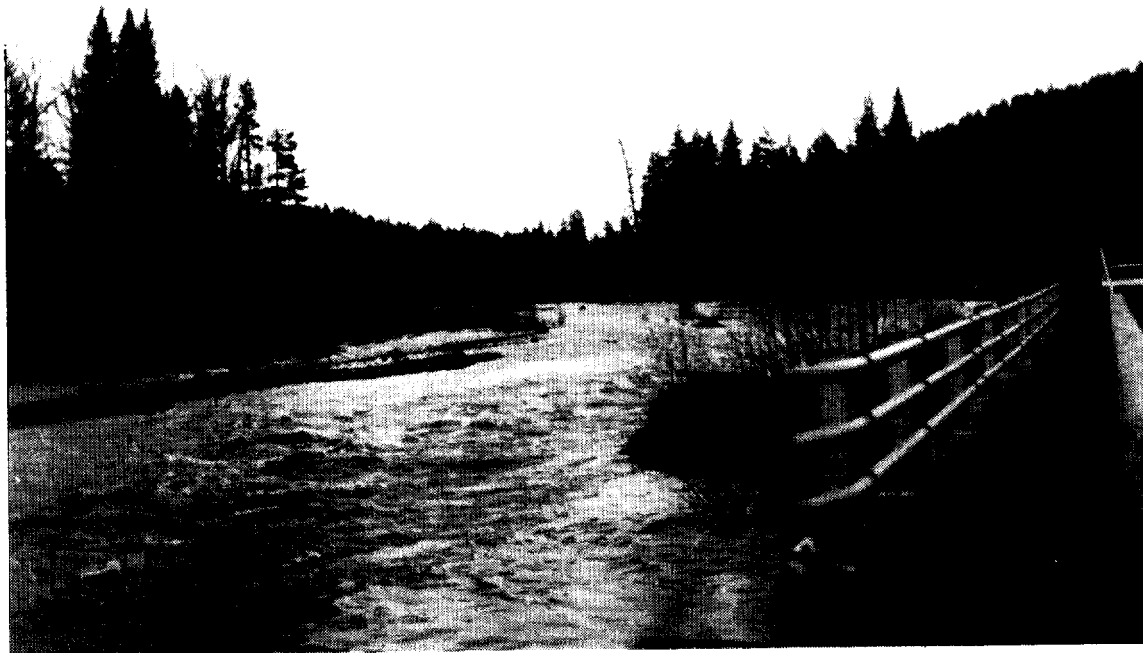
LOOKING UPSTREAM FROM QUARTZ CREEK BRIDGE
FLOOD EVENT NOVEMBER 25, 1990

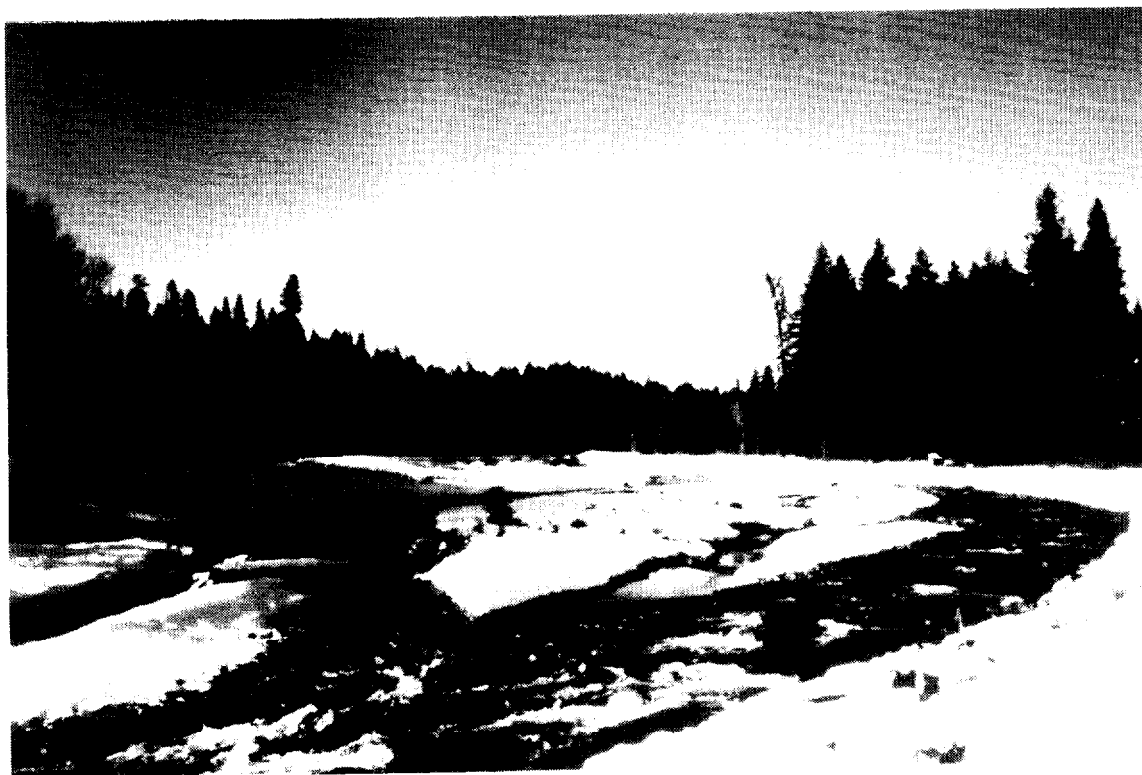
LOOKING UPSTREAM FROM QUARTZ CREEK BRIDGE
180 CFS DECEMBER 6, 1990
INCREASED BRAIDING AFTER FLOOD EVENT

- 2) LOG SILLS- The channel cross sections appear unchanged over the last four years, except the 1989 and 1990 elevations are approximately a foot lower than the 1988 and 1987 elevations. This is most likely an error in the 1989 field notes, as this portion of the channel does not visually appear to have changed much since the structure was installed in 1986 (1990 starting elevation was generated from the mistaken 1989 elevation). The last four springs have not produced large enough flood events to cause any significant channel changes. The recent November 1990 flood exposed the previously buried downstream-most log sill, and stream channel braiding was greatly increased in this area and downstream.

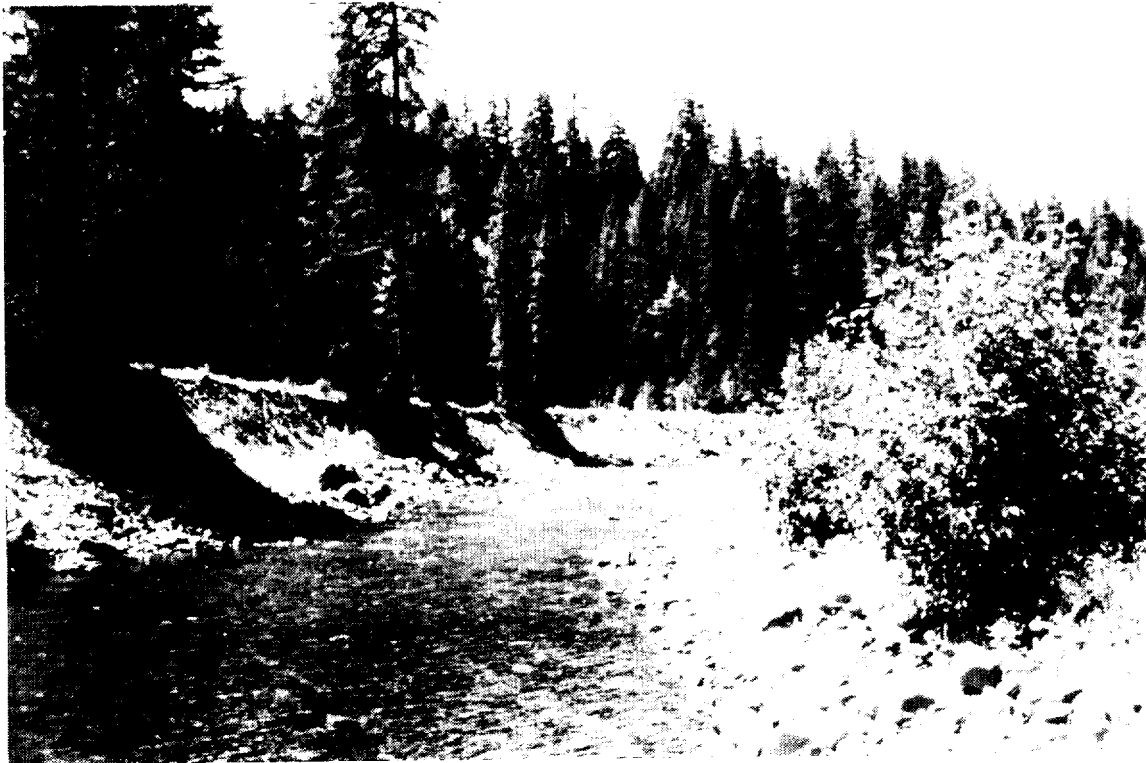
UPSTREAM FROM LOG SILLS
AUGUST 4, 1988

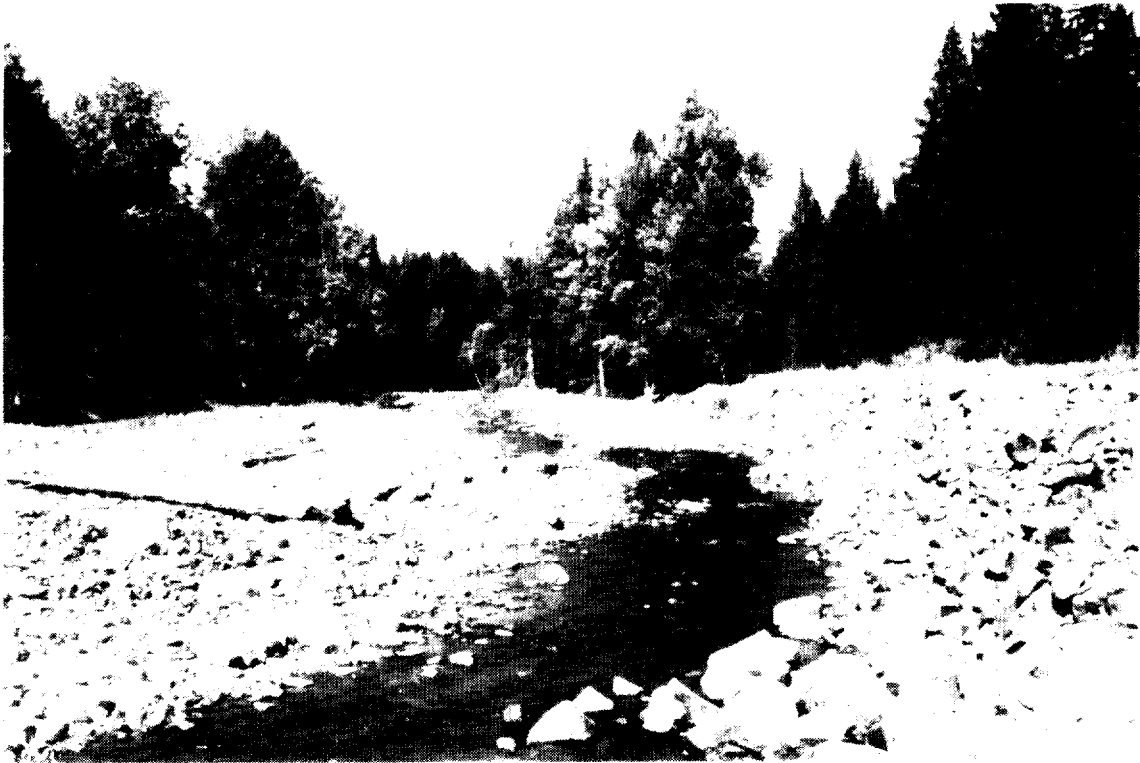
UPSTREAM FROM ROCK TRIOS
AUGUST 27, 1987

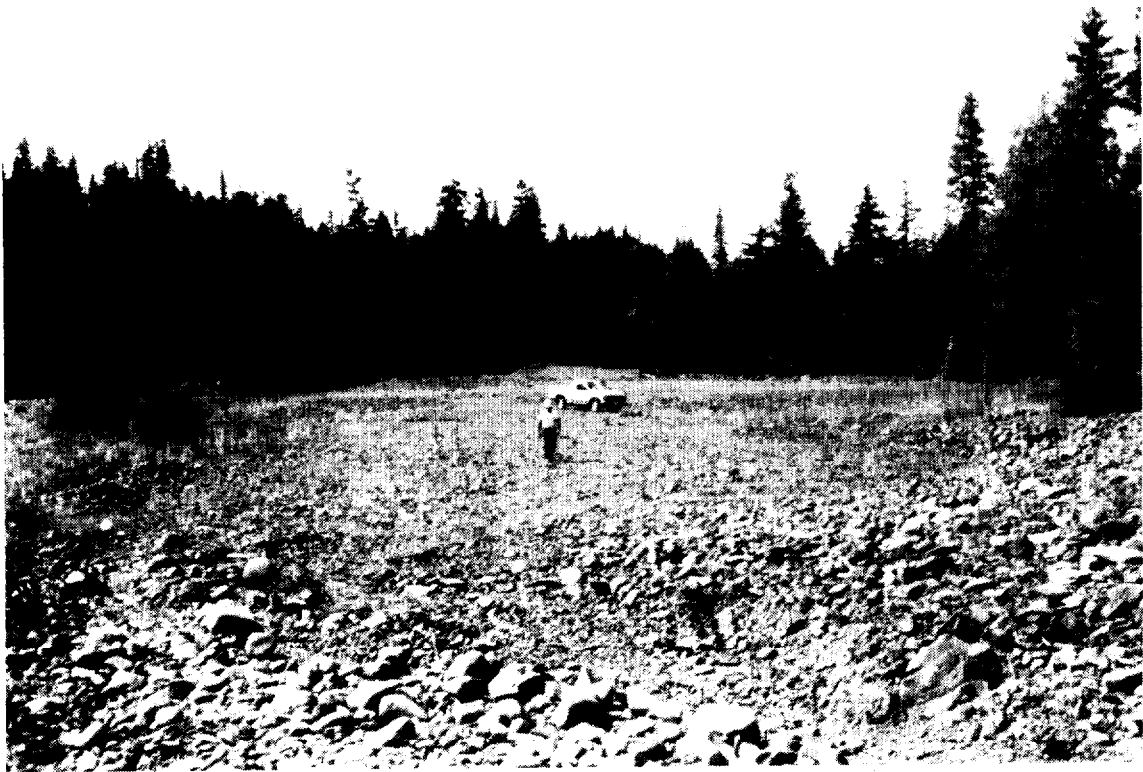
VEGETATION PHOTO POINT
LOOKING NW ALONG BERM FROM LOG SILL AREA
AUGUST 27, 1987

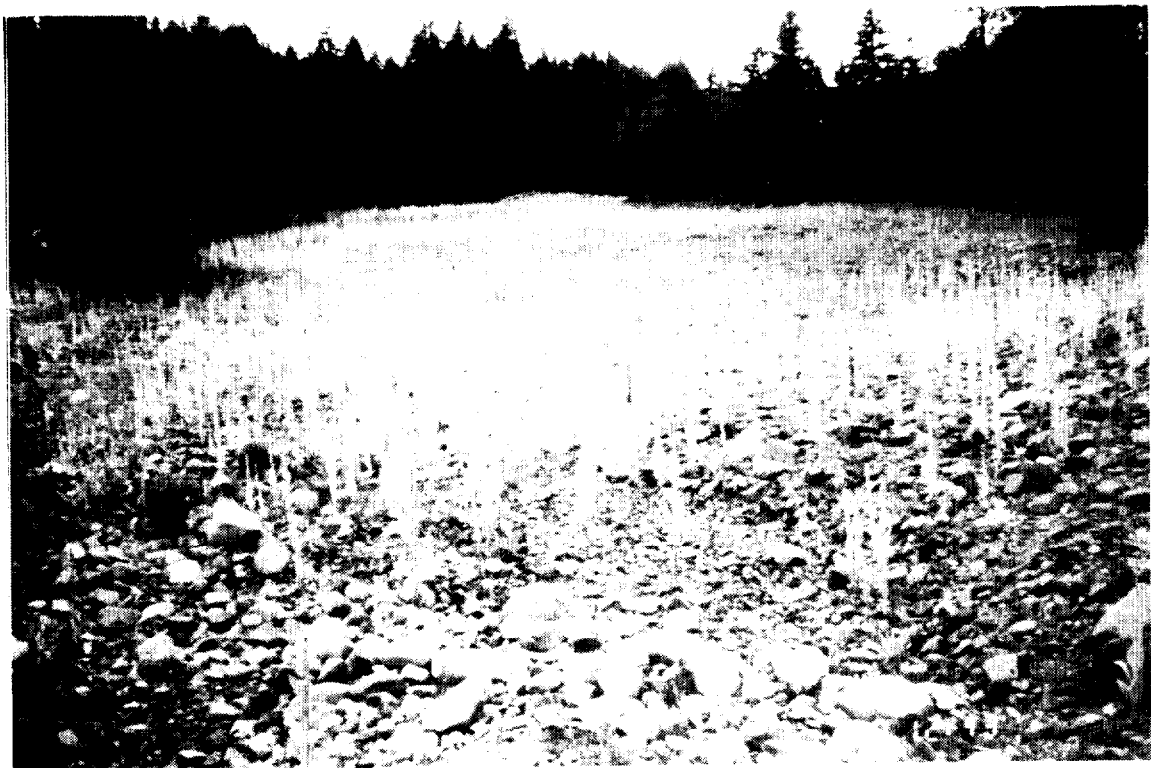
VEGETATION PHOTO POINT
LOOKING NW ALONG BERM FROM LOG SILL AREA
AUGUST 30, 1990

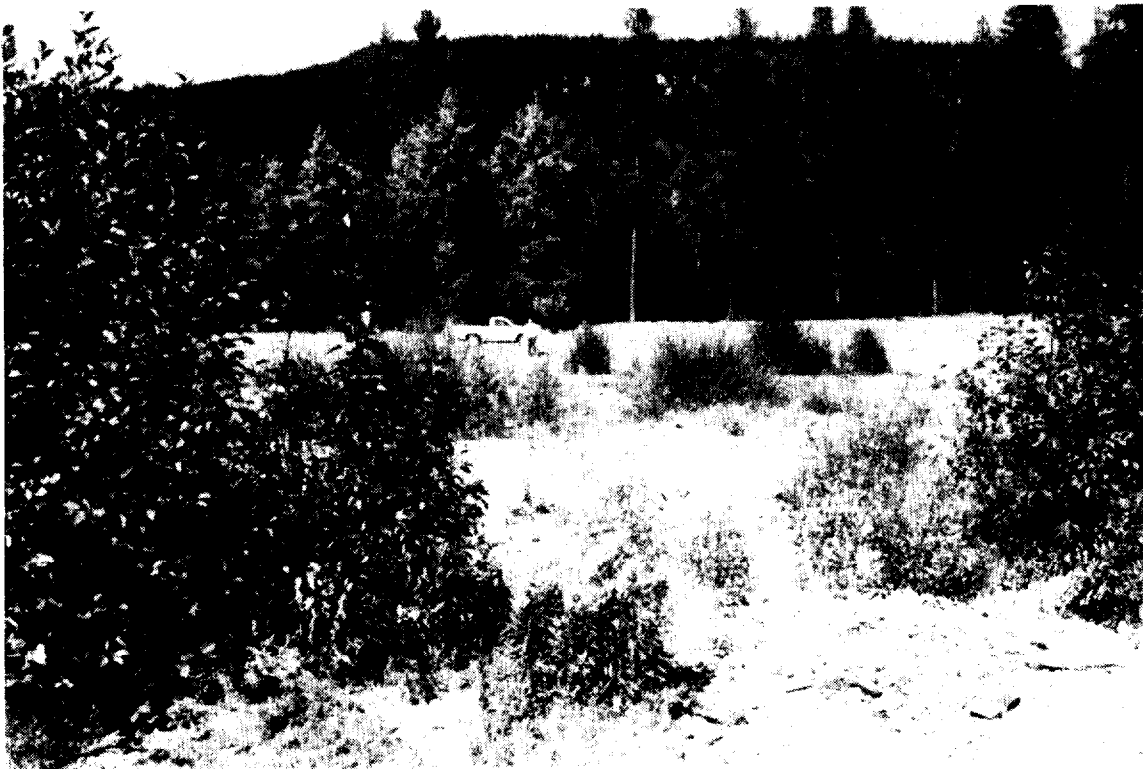
VEGETATION PHOTO POINT
 LOOKING FROM 0 FT. TO 180 FT. ALONG VEG. PLOT LINE
 RANDOM ROCKS 2 VICINITY SEPTEMBER 8, 1987

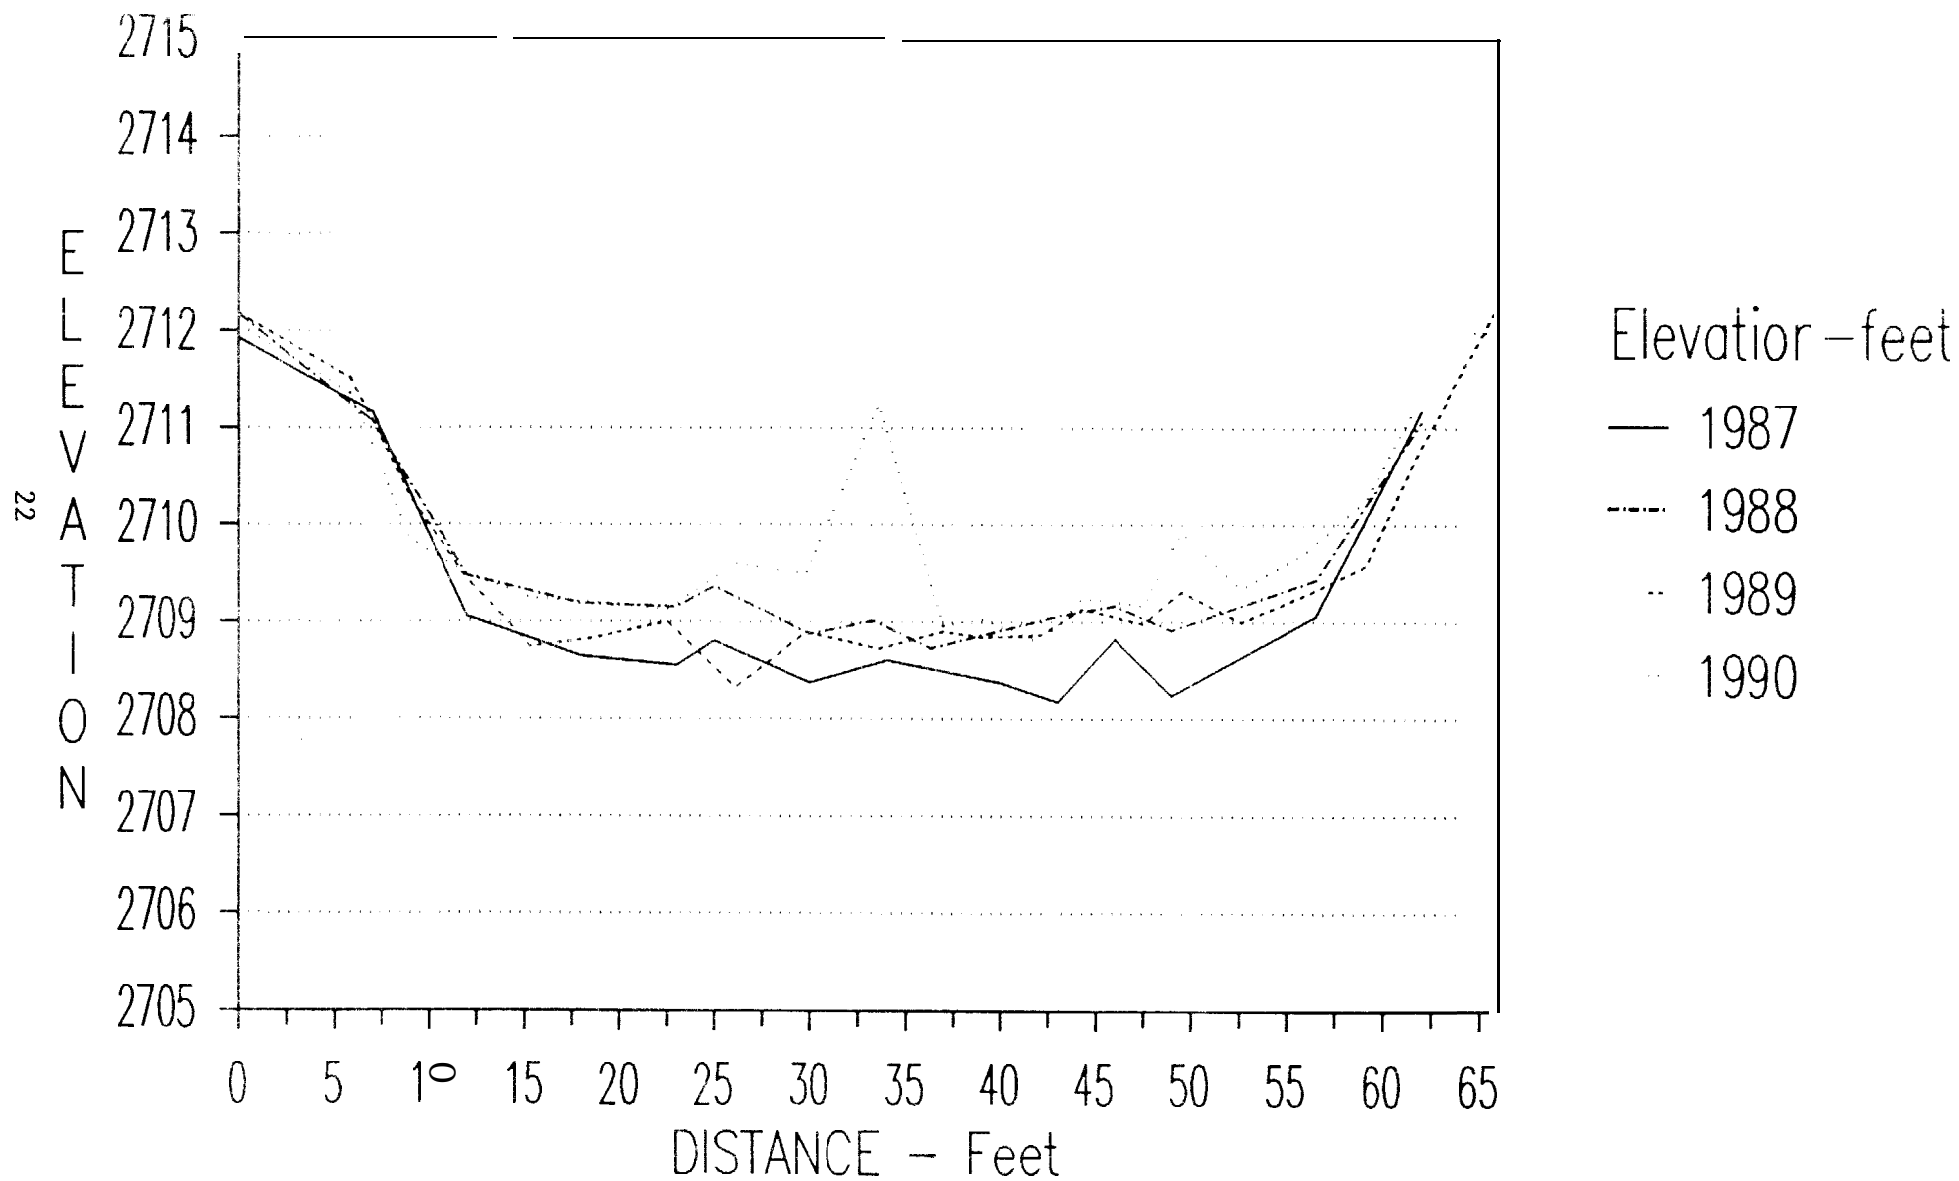
TRANSECT #1 (TRAND1)

- 1) RANDOM ROCKS 1- The channel cross sections appear generally unchanged over the last four years. For 1990, transect #1 has a peak at 33 feet that occurs on a boulder, and the far bank may be higher because it is on a steep riprapped area that could have shifted.
